#### PUBLIC UTILITIES COMMISSION

November 4, 2021 GA2021-06PE

SUBJECT: Audit of Solar Star 1 & 2

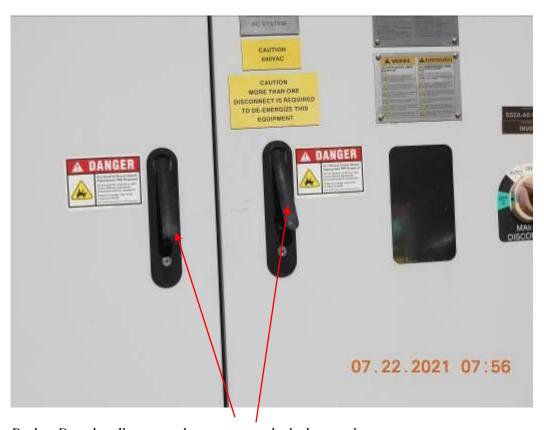
ESRB Inspectors witnessed several broken door handles of the inverters and also some doors were not locked properly.

Broken Door handles, some doors were not locked properly

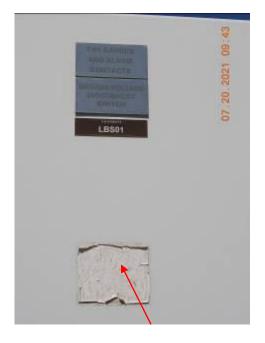
ESRB Staff observed some sound warning signs deteriorated beyond recognition. The plant personnel informed ESRB that the plant had performed a study and found the sound level below the threshold level of Cal OSHA. ESRB staff recommended that plant personnel take off the sign completely to avoid confusion.

Deteriorated Warning Sign

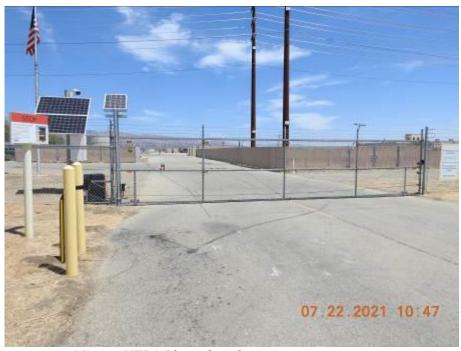
ESRB observed that the Plant's main gate did not have a National Fire Protection Association (NFPA) 704 warning placard. The Plant stockpiles and uses hazardous chemicals as part of its normal operation. NFPA 704 is a standard system for identifying hazards of materials for emergency response. The posting of an NFPA placard on the main gate is a common industry practice so first responders can quickly and easily identify the risks posed by a facility's hazardous materials. This helps emergency personnel to determine what safety gear and precautions to use and how best to respond in emergencies.

Missing NFPA Placard on the main gate.

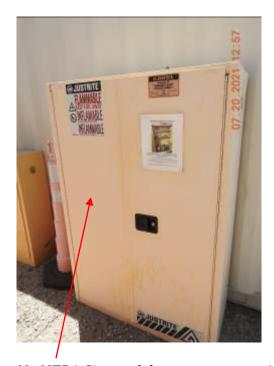
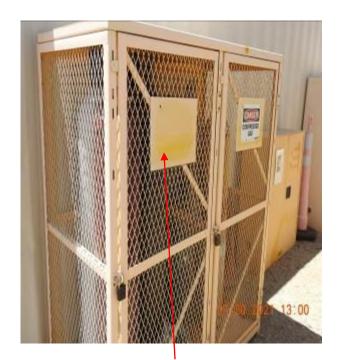
ESRB staff found a missing NFPA sign (the fire diamond) on the cylinder storage cabinet and the chemical cabinets were not equipped with a self-latching device.

No NFPA Sign and doors were not equipped with the self-latching device.

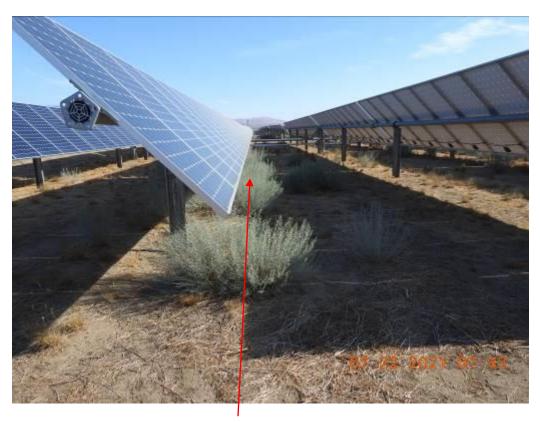
ESRB staff observed vegetation near one of the solar panels which is a fire threat hazard.

Vegetation near solar panel

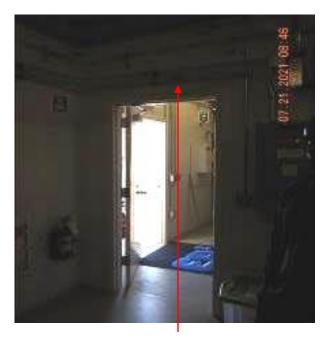
ESRB staff observed no exit sign in the battery storage rooms. Batteries contain acids that are considered a hazard and in case of an emergency, the Exit sign should be visible to all occupants.

No Exit sign

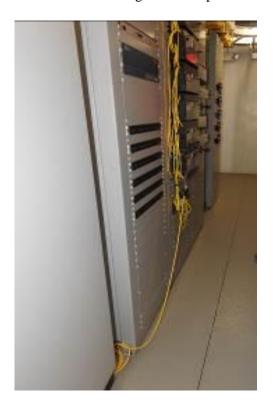
ESRB Inspectors found fiber cables extending out of the panel and not properly tied.
